# Water Damage on main board of Nokia 206 RM873

This Nokia 206 fell in a sink full of water. The battery was dead, but the motherboard was fixable.

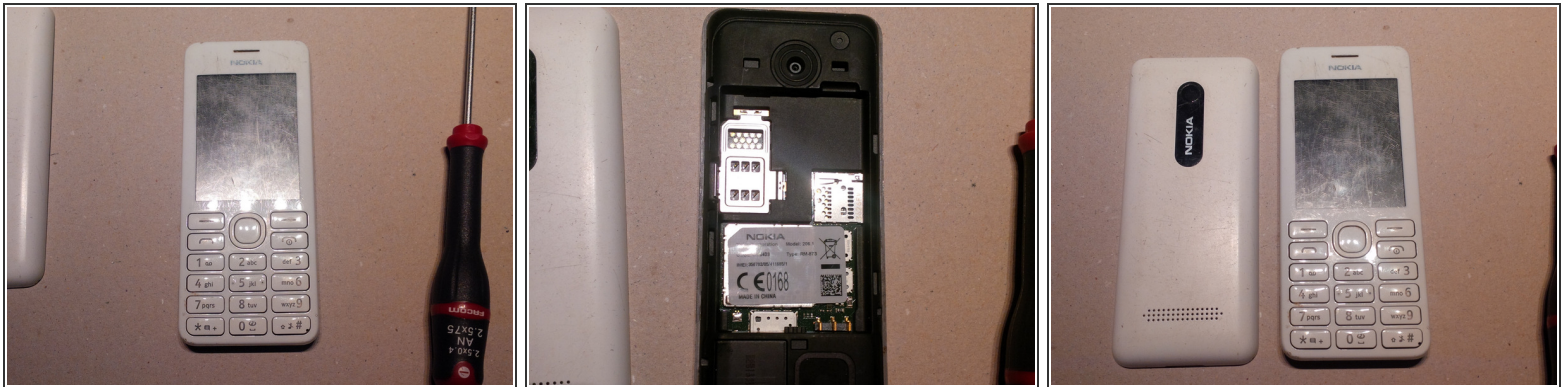
## Step 1 — Water Damage on main board of Nokia 206 RM873

- Remove back cover & battery.

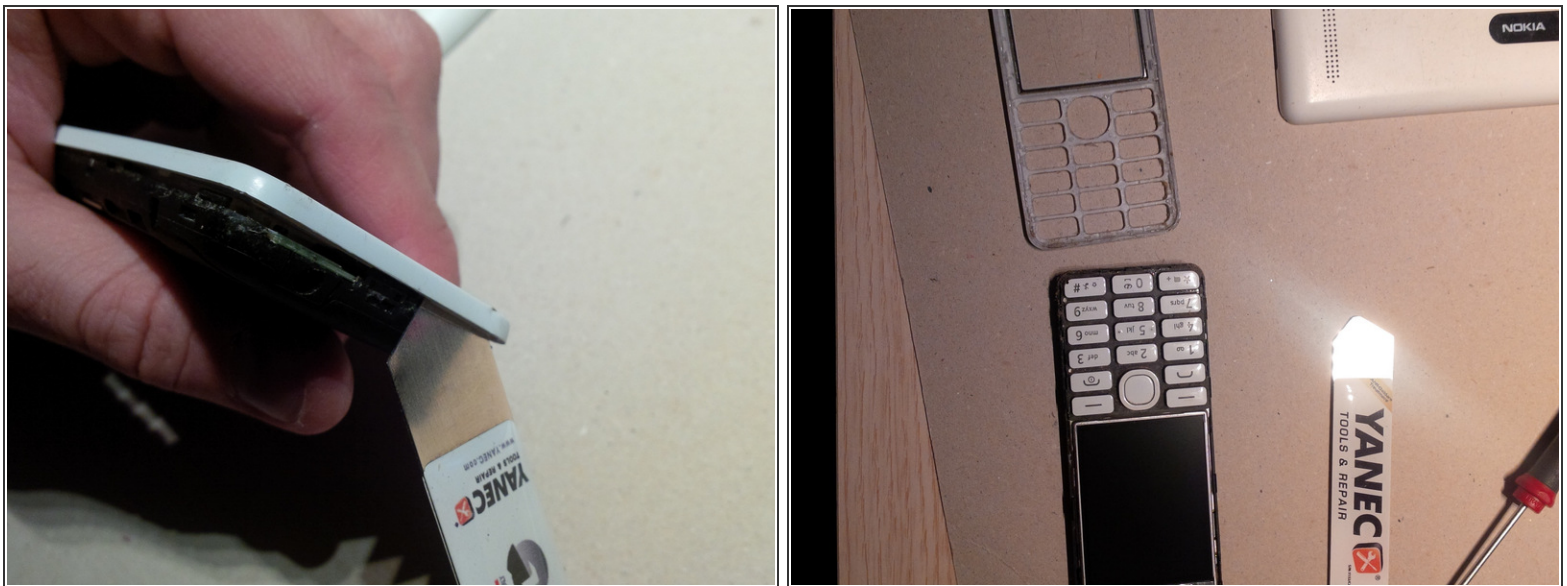
## Step 2

- Remove the front case by prying it open. You will hear clicks.

⚠ Be careful with taking off screen if you use a spudger.

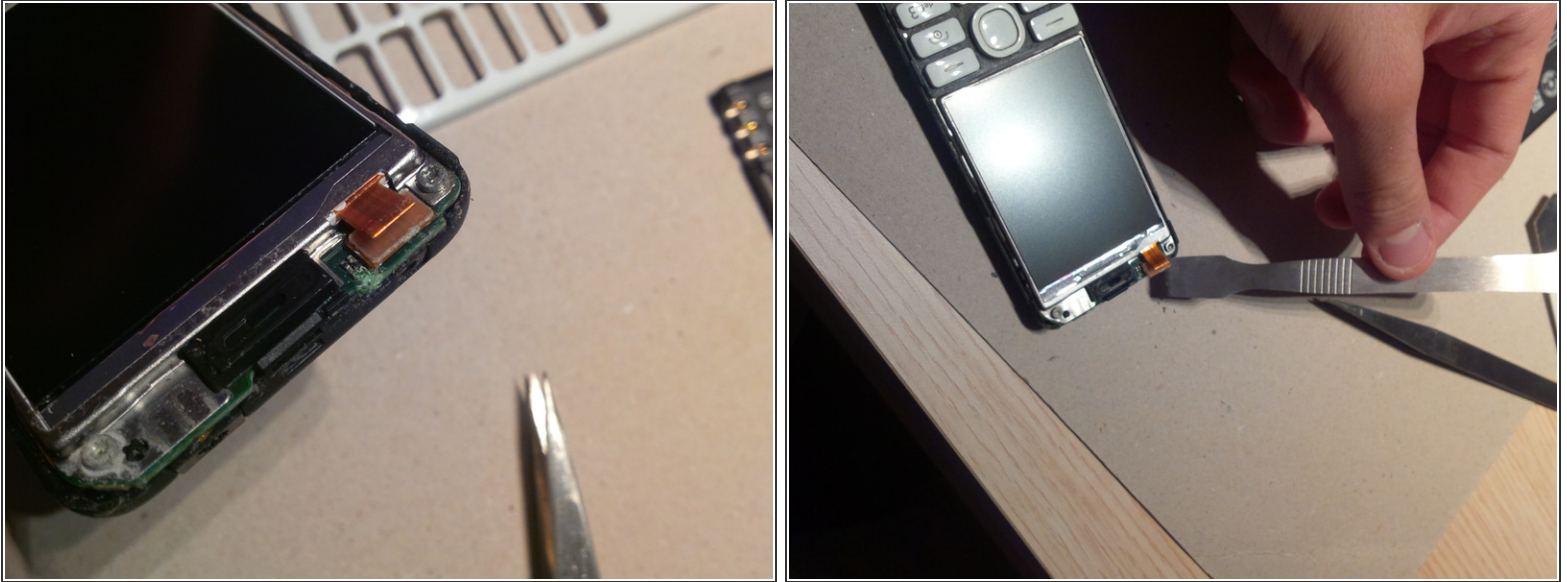
## Step 3

- Use a Torx screwdriver to remove the screen screws.
- Use a spudger or tweezers to remove the connector of the LCD screen.

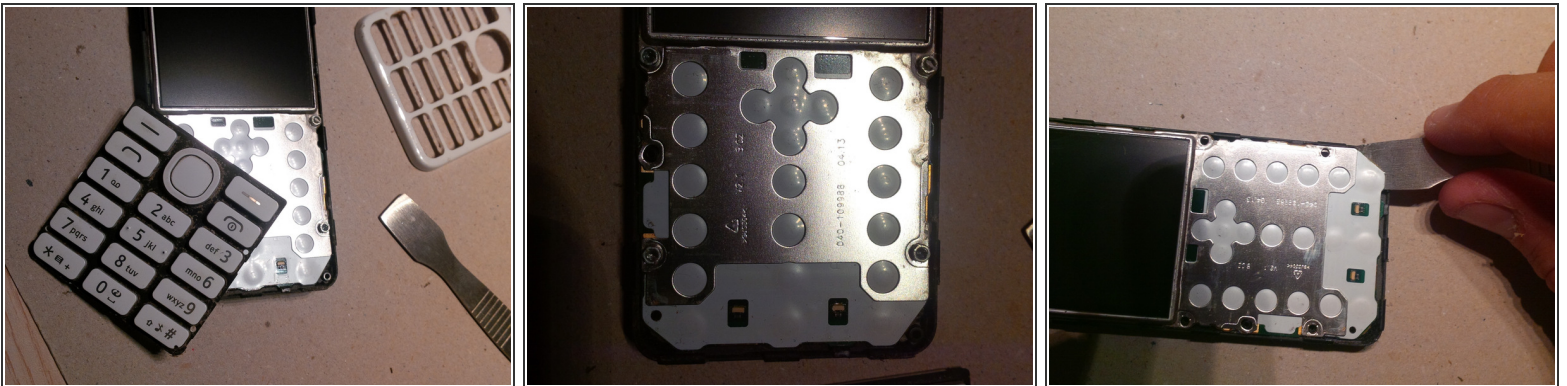
## Step 4

- Remove keyboard by prying it open with a spudger.

⚠ The keyboard is secured with adhesive, be careful!
